Debris/Ice/TPS Assessment And Photographic Analysis For Shuttle Mission STS-31R

June 1990

Charles G. Stevenson
NASA/Kennedy Space Center

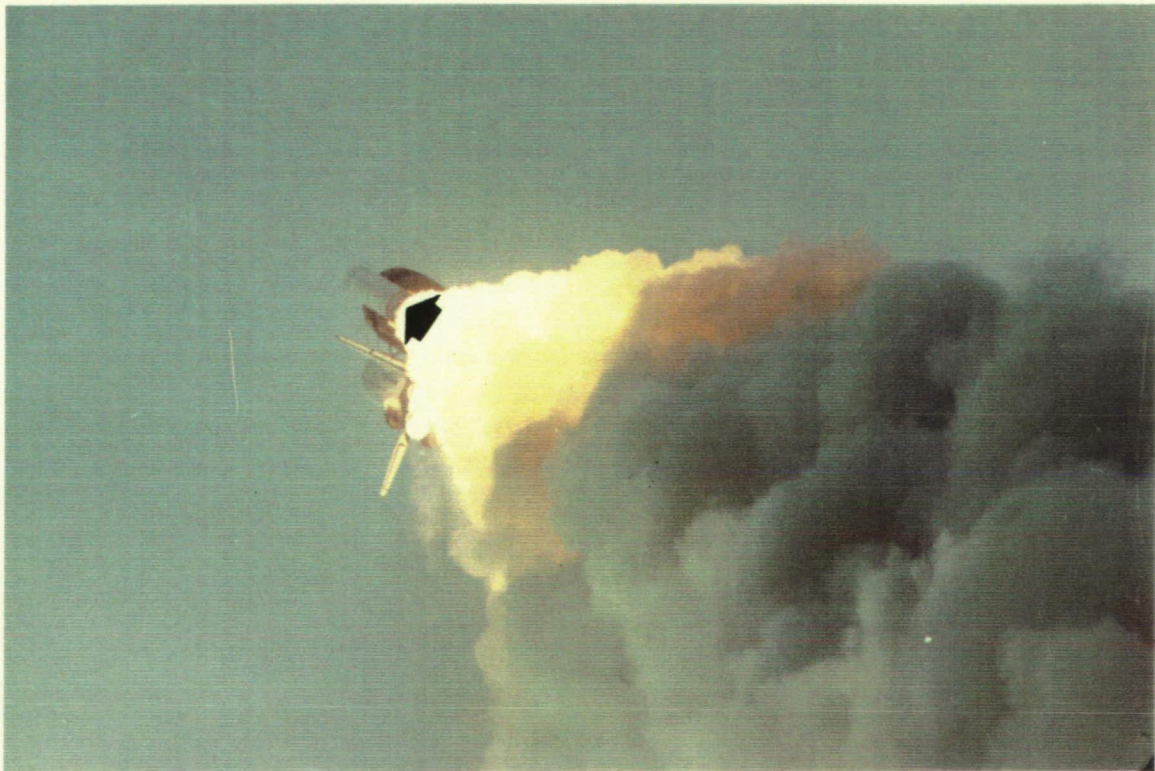
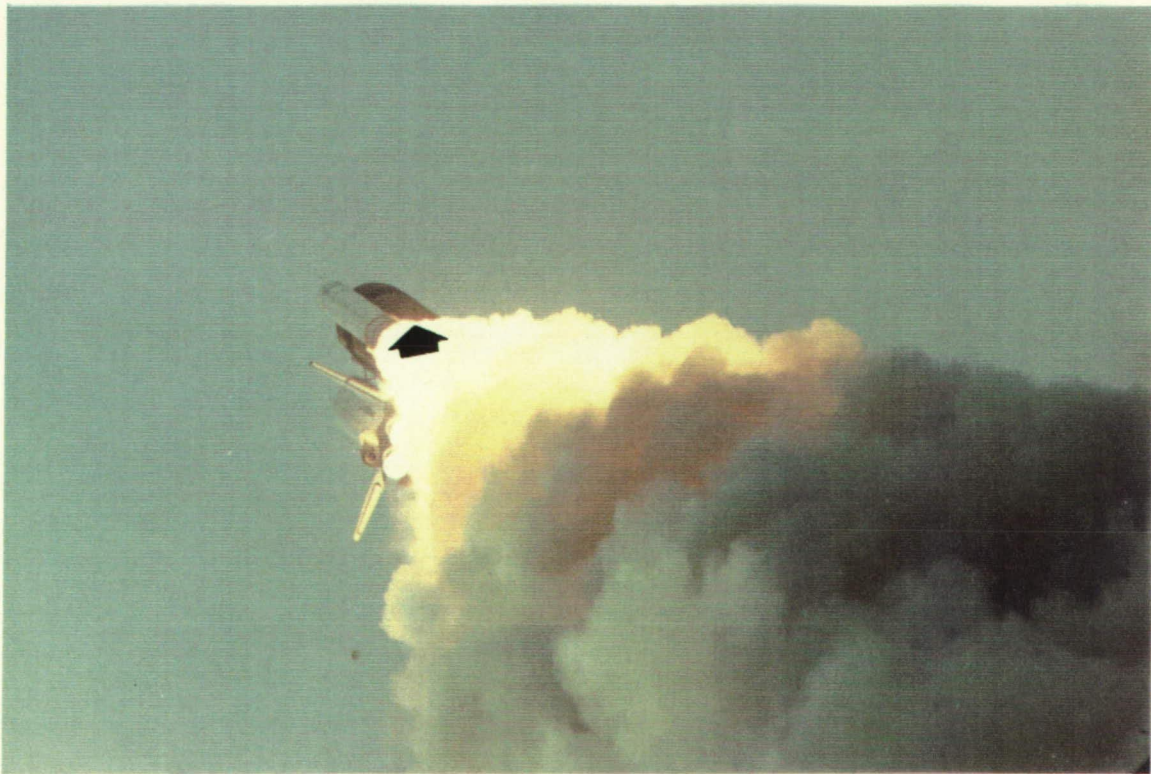
An ordnance debris fragment falls from the RH SRB HDP #1
stud hole shortly after liftoff (E-8)

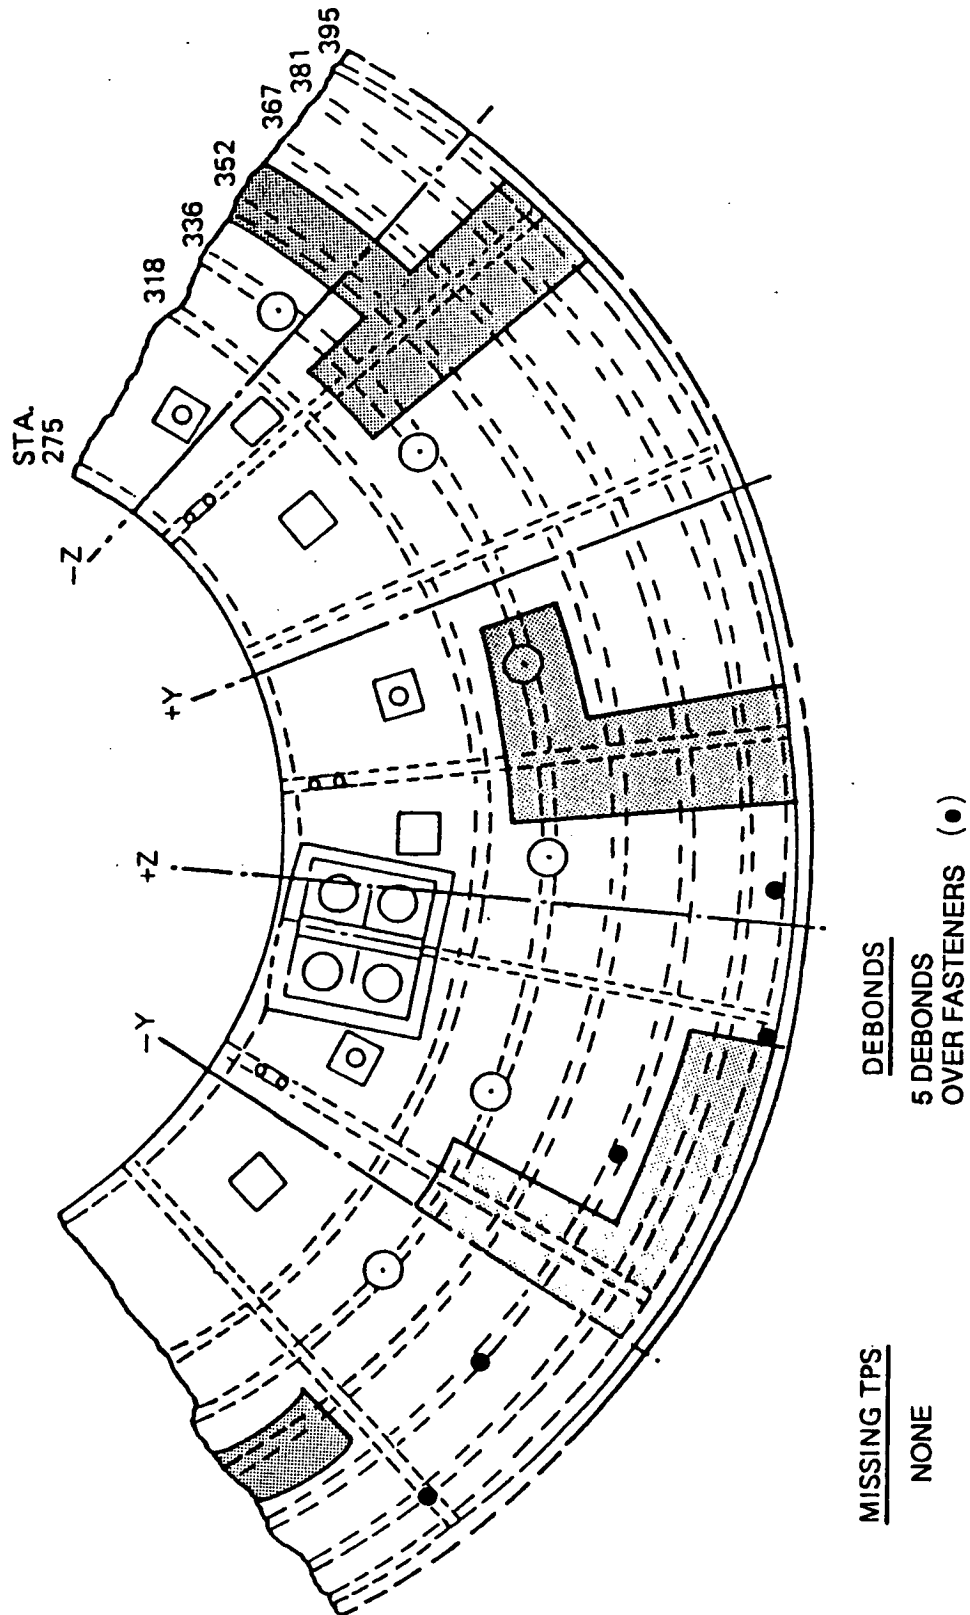
FIGURE 11. RIGHT SRB FRUSTUM

The nosecap was not recovered. The RH frustum had no areas of missing TPS but had 5 debonds over fasteners (Figure 11). The Hypalon paint had blistered slightly in localized areas. Some layers of MSA had adhered to the paint. The BSM covers were fully opened and locked in the 180 degree position.

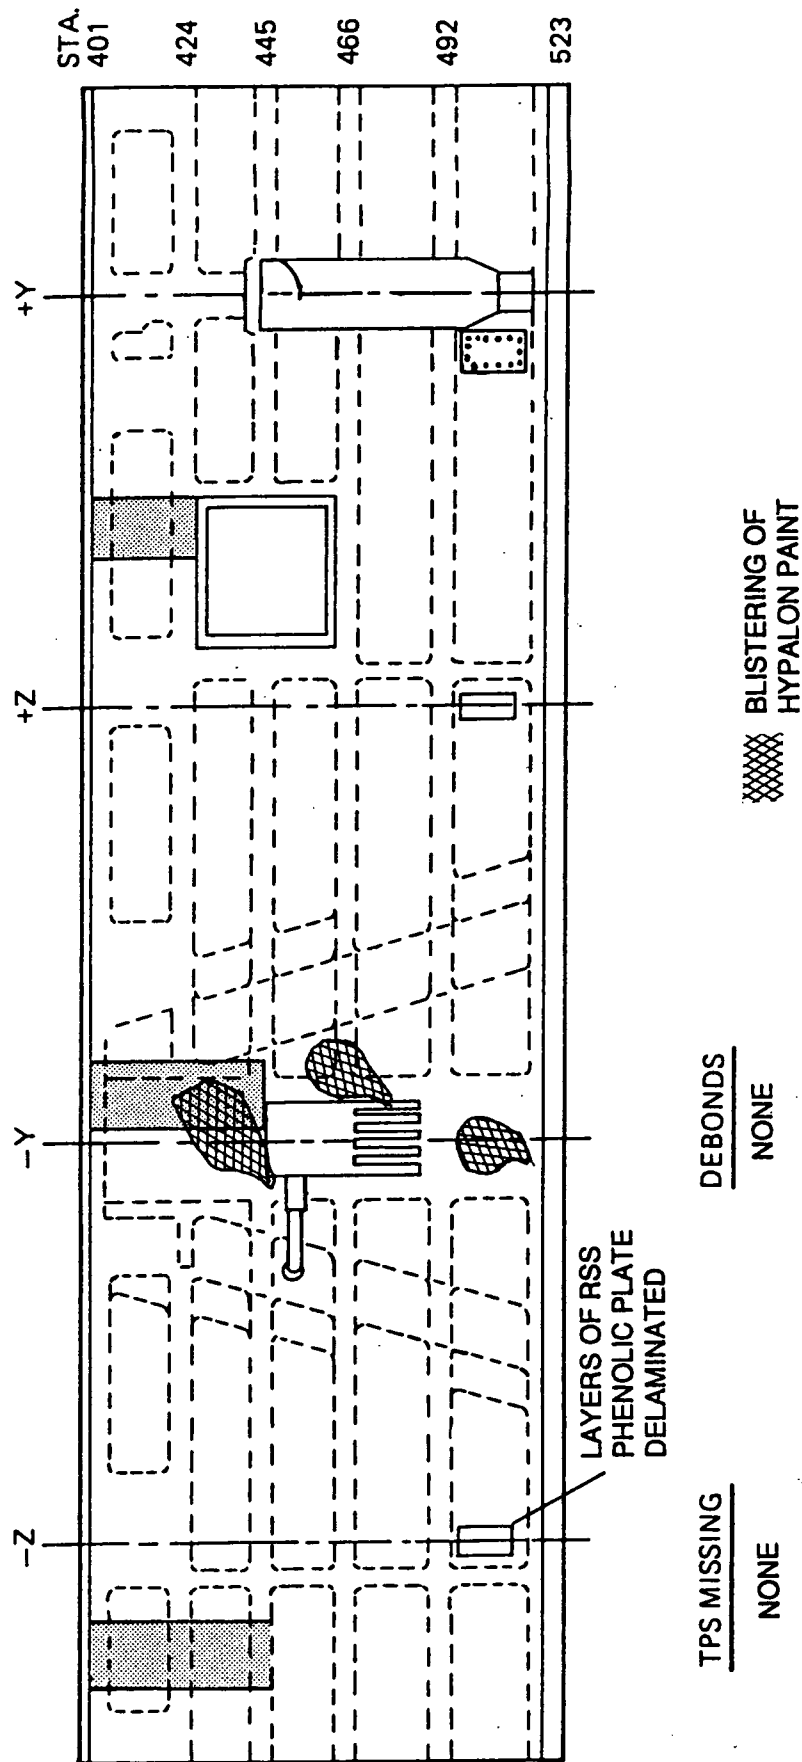
FIGURE 12. RIGHT SRB FWD SKIRT

The RH forward skirt exhibited no debonds or missing TPS. The phenolic plate on the -Z RSS antenna had some delaminated layers (Figure 12). Separation of the forward attach bolt appeared normal. K5NA closeouts on the inboard corners of the RSS interface cable tray were intact.

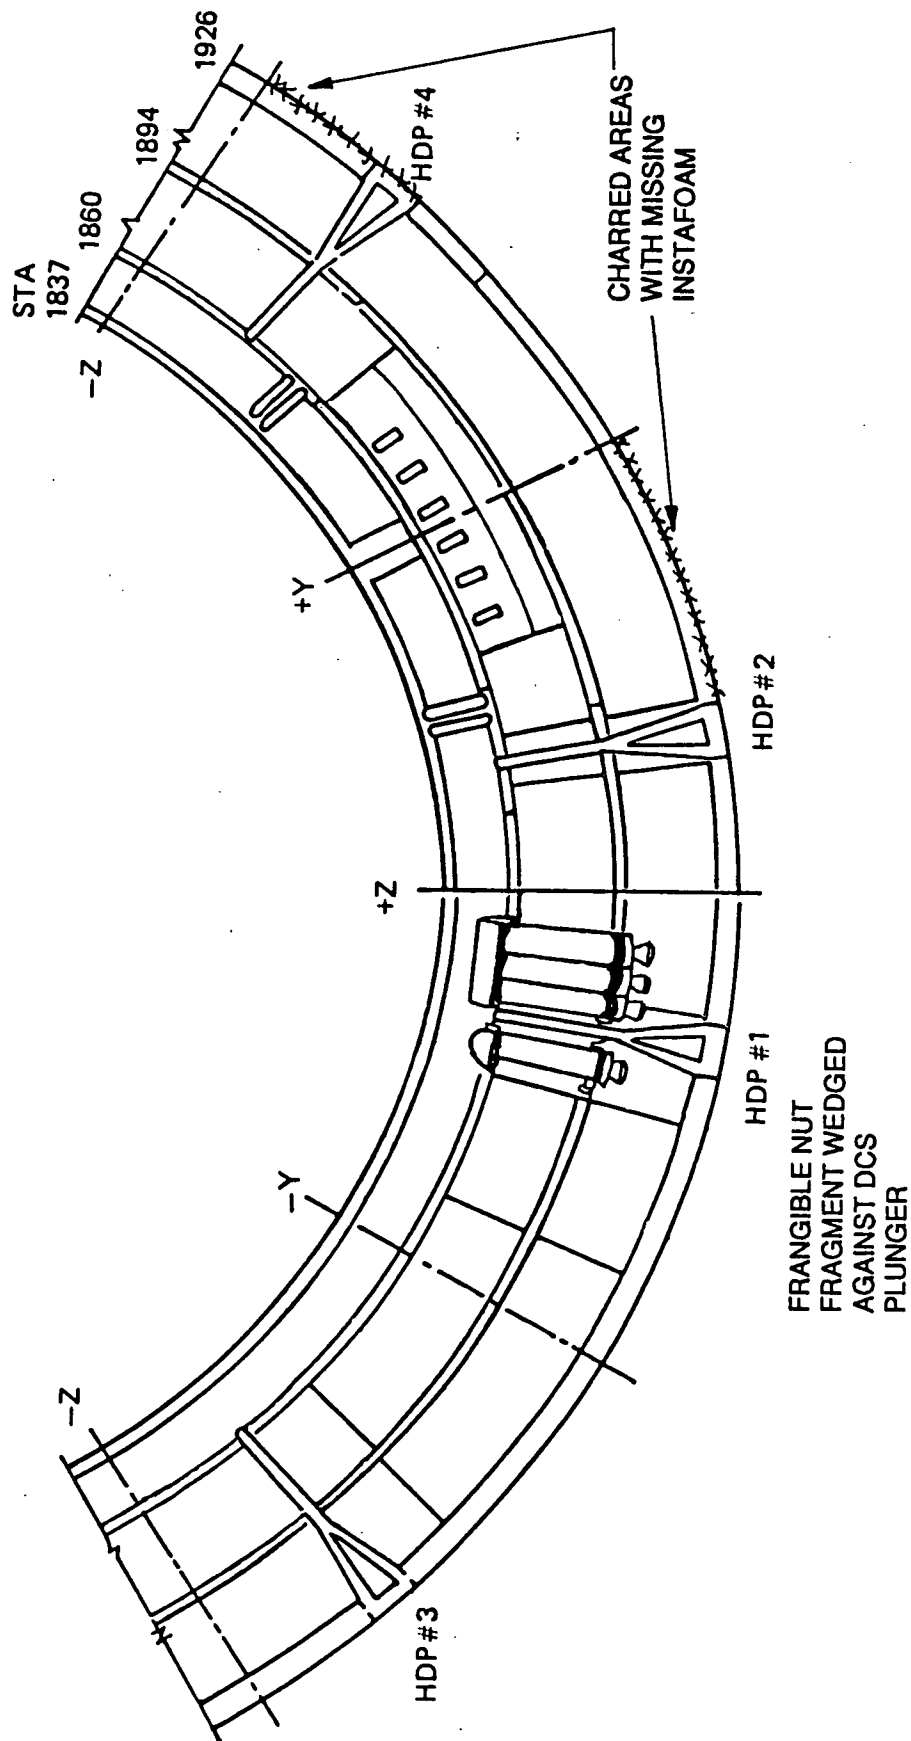
FIGURE 13. RIGHT SRB AFT SKIRT EXTERIOR TPS

The TPS over the aft skirt acreage was generally in good condition (Figure 13). K5NA was missing from all four aft BSM nozzles. The TVC system appeared to be undamaged. The phenolic material on the kick ring delaminated in several locations. K5NA thermal protective domes were missing from bolt heads on the aft side of the kick ring. A 16 x 2.4 inch maximum width piece of closeout cork was missing from the aft segment/aft skirt joint. This was considered to be an adhesive failure due to the unsooted substrate. Instafoam was missing from the aft ring around the aft skirt feet, HPU exhaust horns, and the SRB T-0 umbilical.

Debris Containment System (DCS) plungers for HDP #2, 3, and 4 were properly seated and latched, but a frangible nut fragment prevented the HDP #1 plunger from seating. There was no broaching of any post holes. There were two small 2-inch diameter sooted areas where the HDP #3 Epon shim material was missing. Twenty to thirty percent of the HDP #4 Epon shim material was missing with sooted substrate.

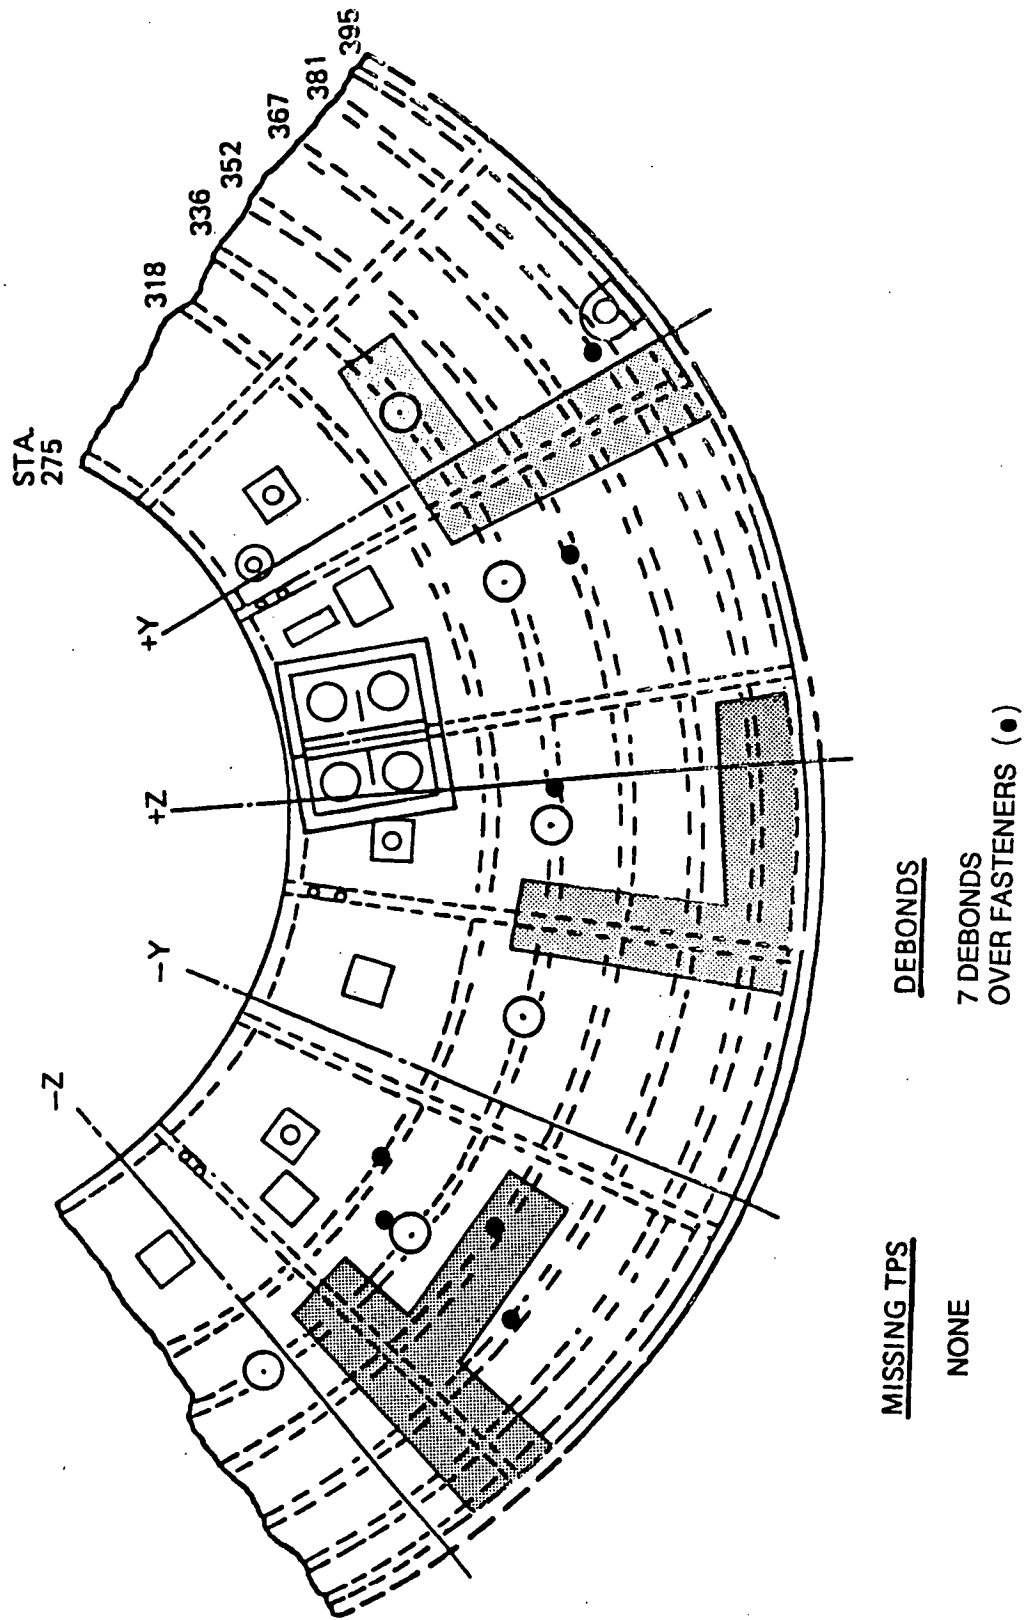
FIGURE 14. LEFT SRB FRUSTUM

The nose cap was not recovered. The LH frustum exhibited no missing TPS but had 7 debonds over fasteners (Figure 14). There was minor blistering of the Hypalon paint in localized areas. The BSM covers were fully opened and locked in the 180 degree open position.

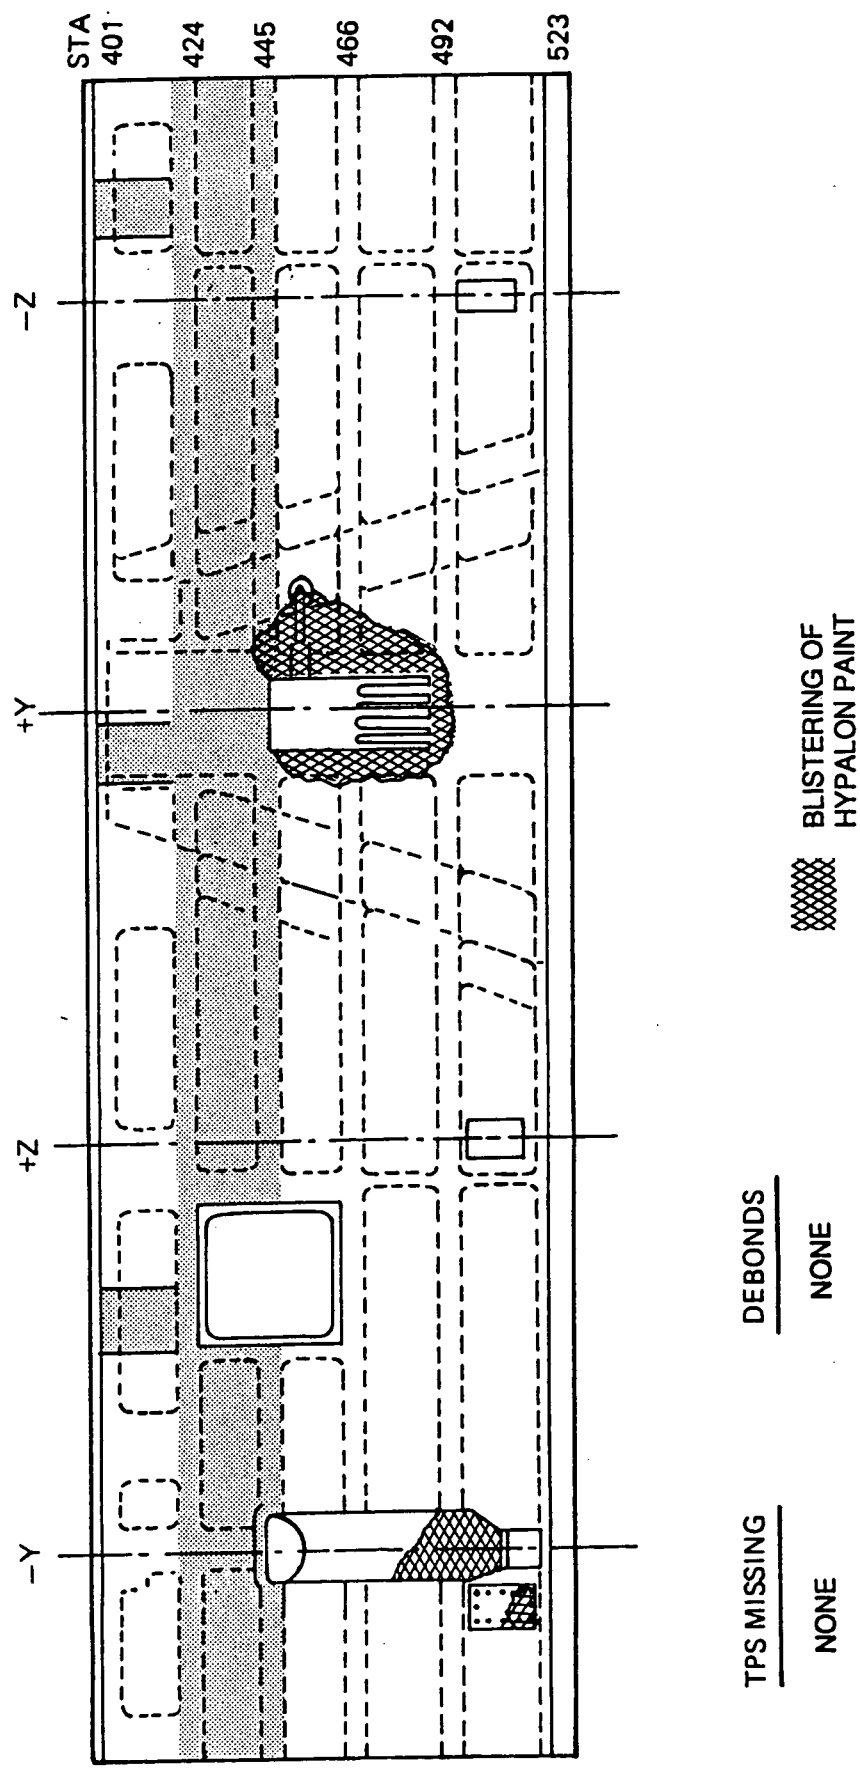
FIGURE 15. LEFT SRB FWD SKIRT

The LH forward skirt exhibited no missing TPS or debonds. Localized areas of Hypalon paint blistered with layers of MSA-2 attached to the paint (Figure 15). Separation of the forward attach bolt was nominal and the RSS cables separated cleanly. The K5NA closeouts on the inboard corners of the RSS interface cable tray were intact.

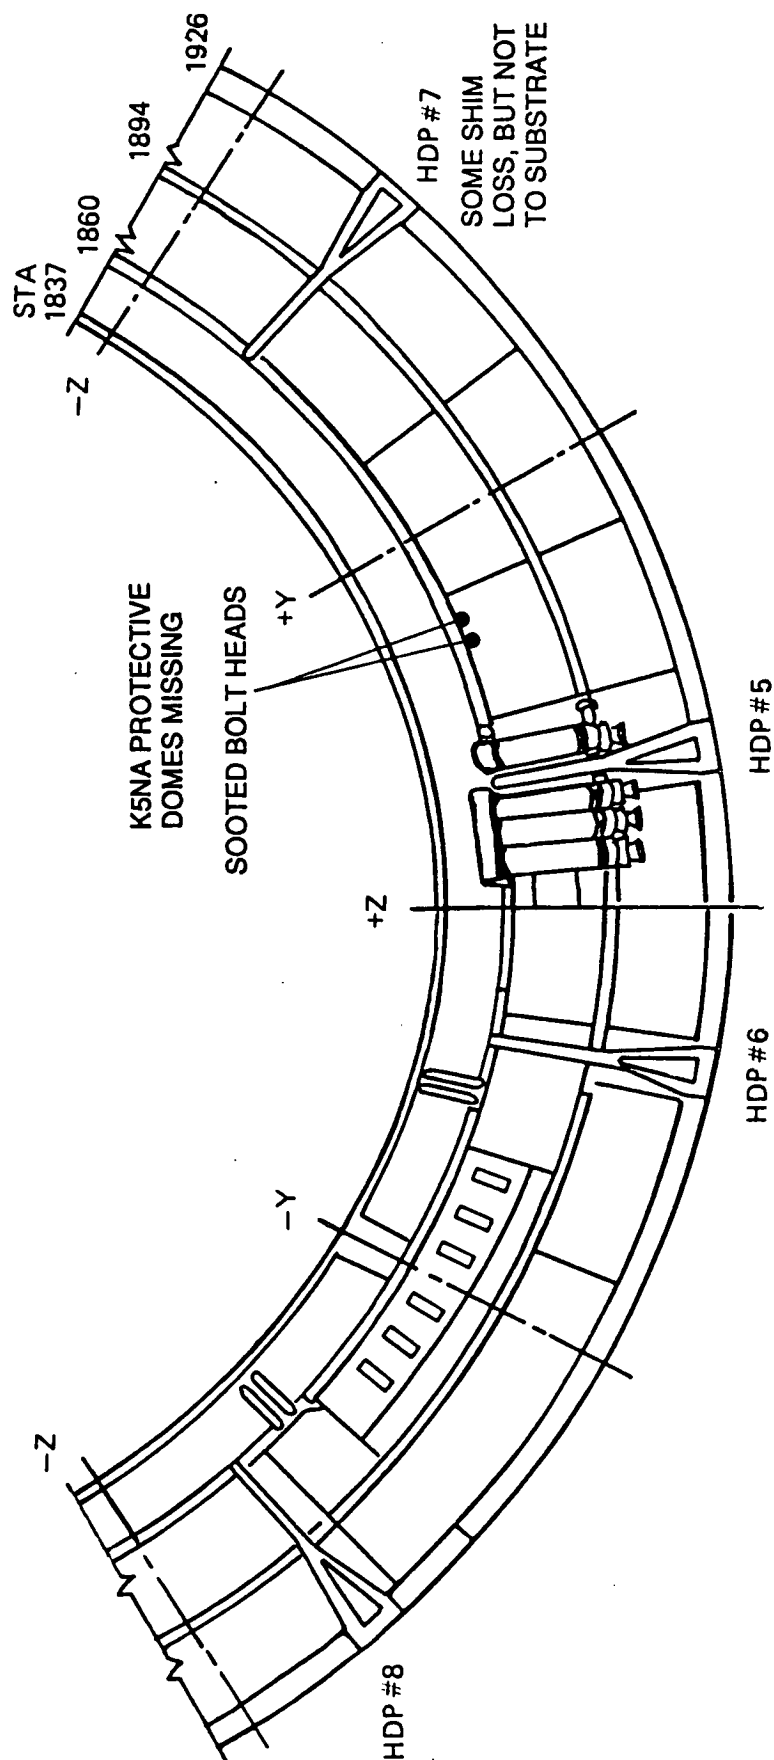
FIGURE 16. LEFT SRB AFT SKIRT EXTERIOR TPS

The TPS over the aft skirt acreage was generally in good condition (Figure 16). The phenolic material on the kick ring delaminated in several locations. Two K5NA protective domes were missing from bolt heads on the aft side of the kick ring with sooted substrate. K5NA was missing from all four BSM nozzles. The TVC system appeared to be undamaged. Instafoam was missing from the aft ring around the skirt feet, HPU exhaust horns, and the SRB T-0 umbilical.

All four DCS plungers were seated and latched. HDP #7 Epon shim exhibited some material loss, but not to substrate.

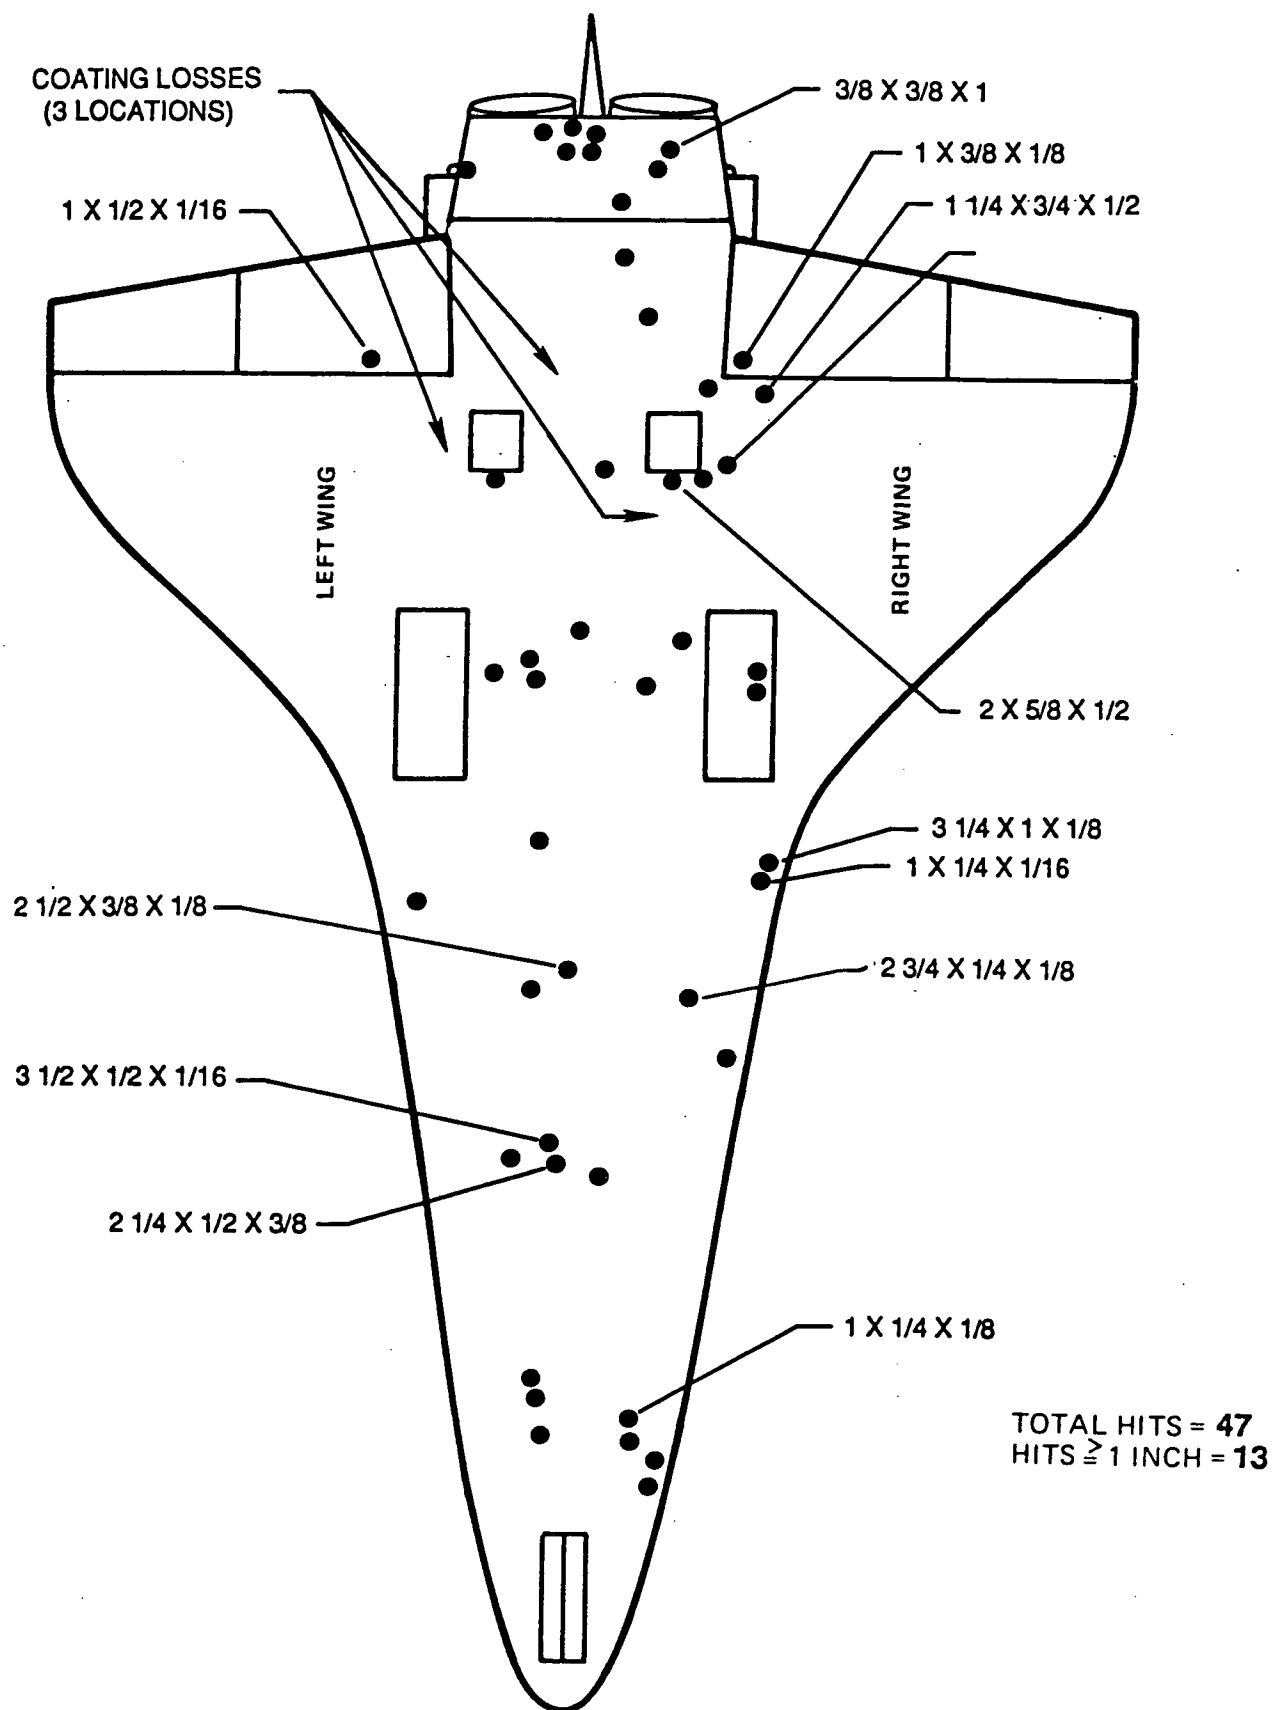
FIGURE 17. DEBRIS DAMAGE LOCATIONS

The Orbiter lower surface had a total of 47 hits of which 13 had a major dimension of one inch or greater. A comparison of these numbers to statistics from 21 previous missions of similar configuration (excluding missions STS-24, 25, 26, 26R, 27R, and 30 which had damage from known debris sources), indicates the total number of hits on the lower surface less than average. Figures 17 - 20 show the TPS debris damage assessment for STS-31R.

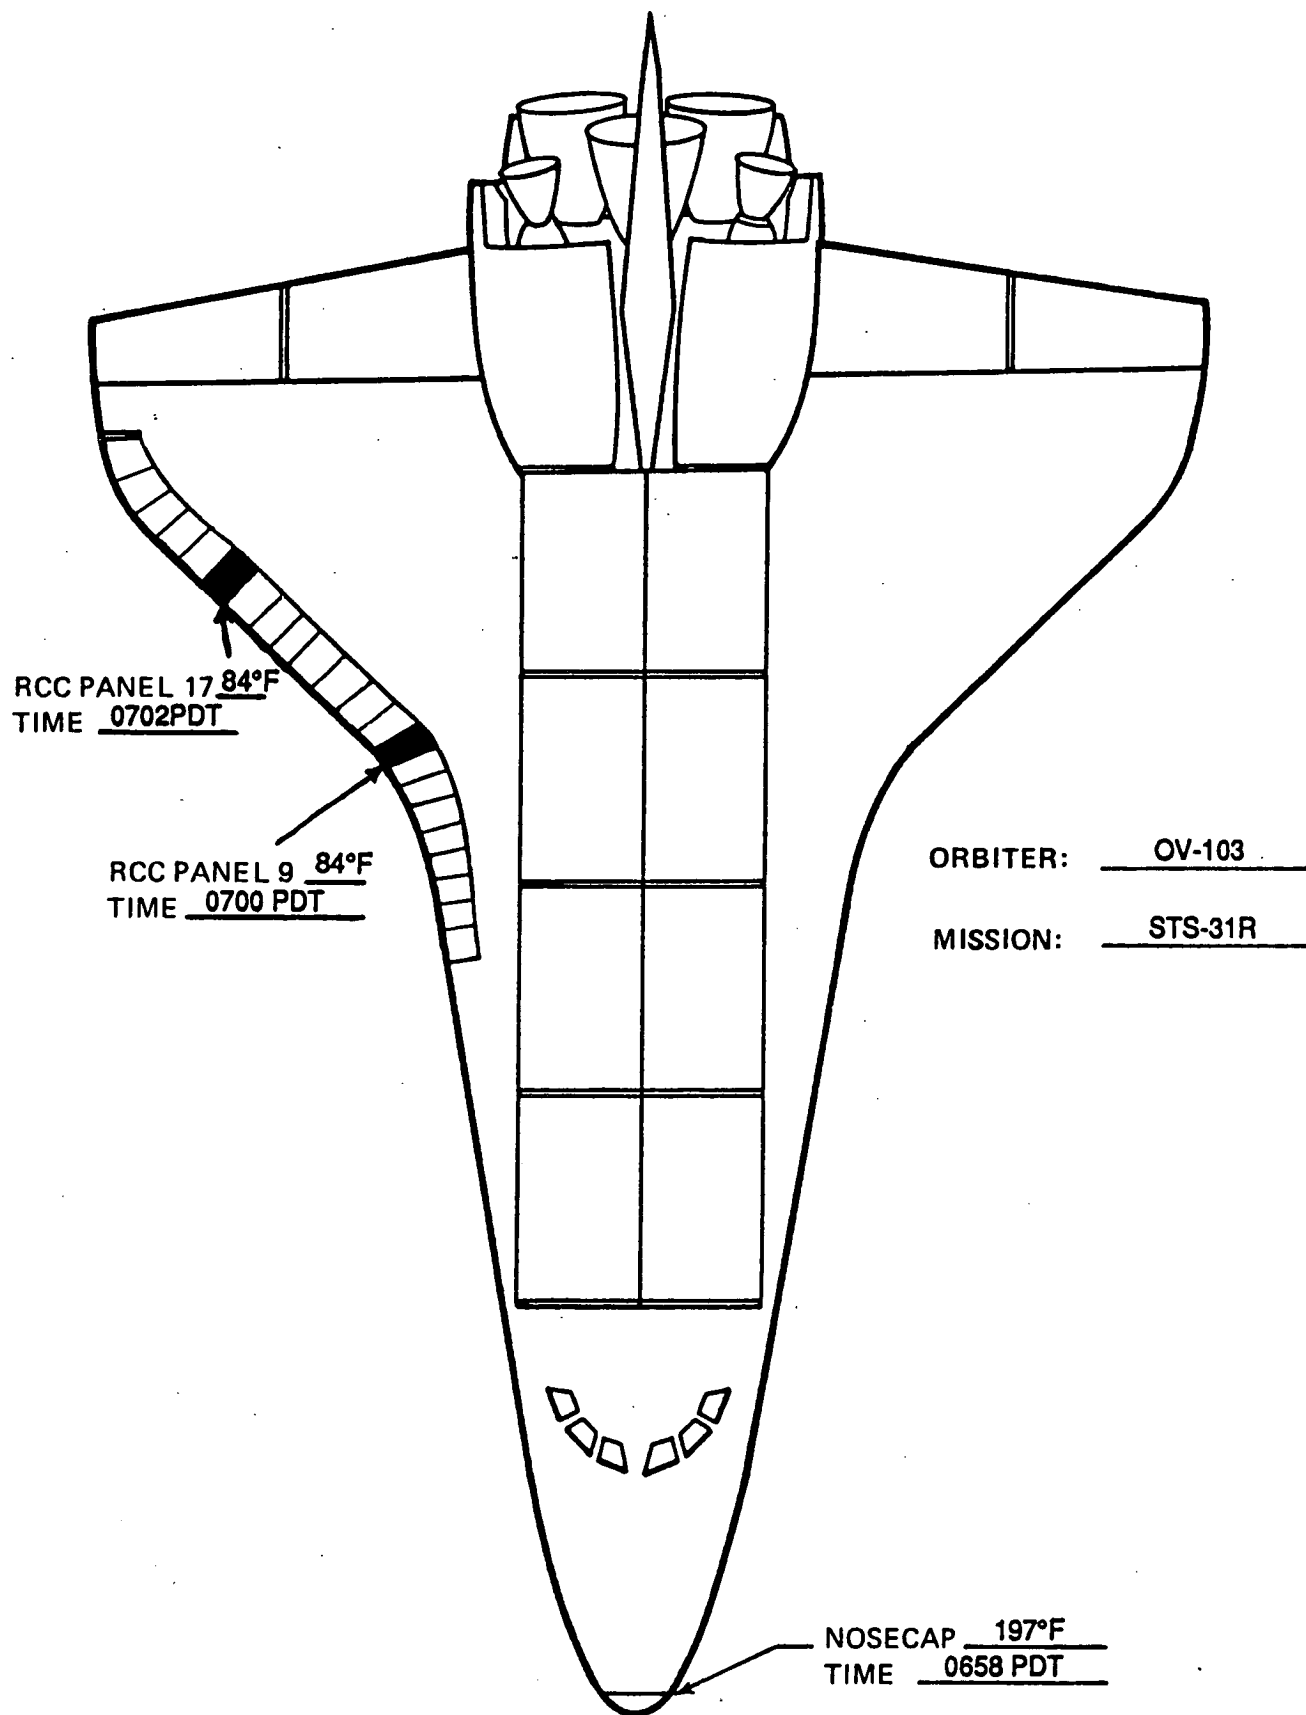
FIGURE 23. TEMPERATURE MEASUREMENTS

The KSC Shuttle Thermal Imager (STI) was used to record the kinetic surface temperatures of several areas (Figure 23). Nine minutes after landing the noscap RCC measured 197 degrees F. Twelve minutes after landing the RH wing RCC panels #9 and #17 both measured 84 degrees F.

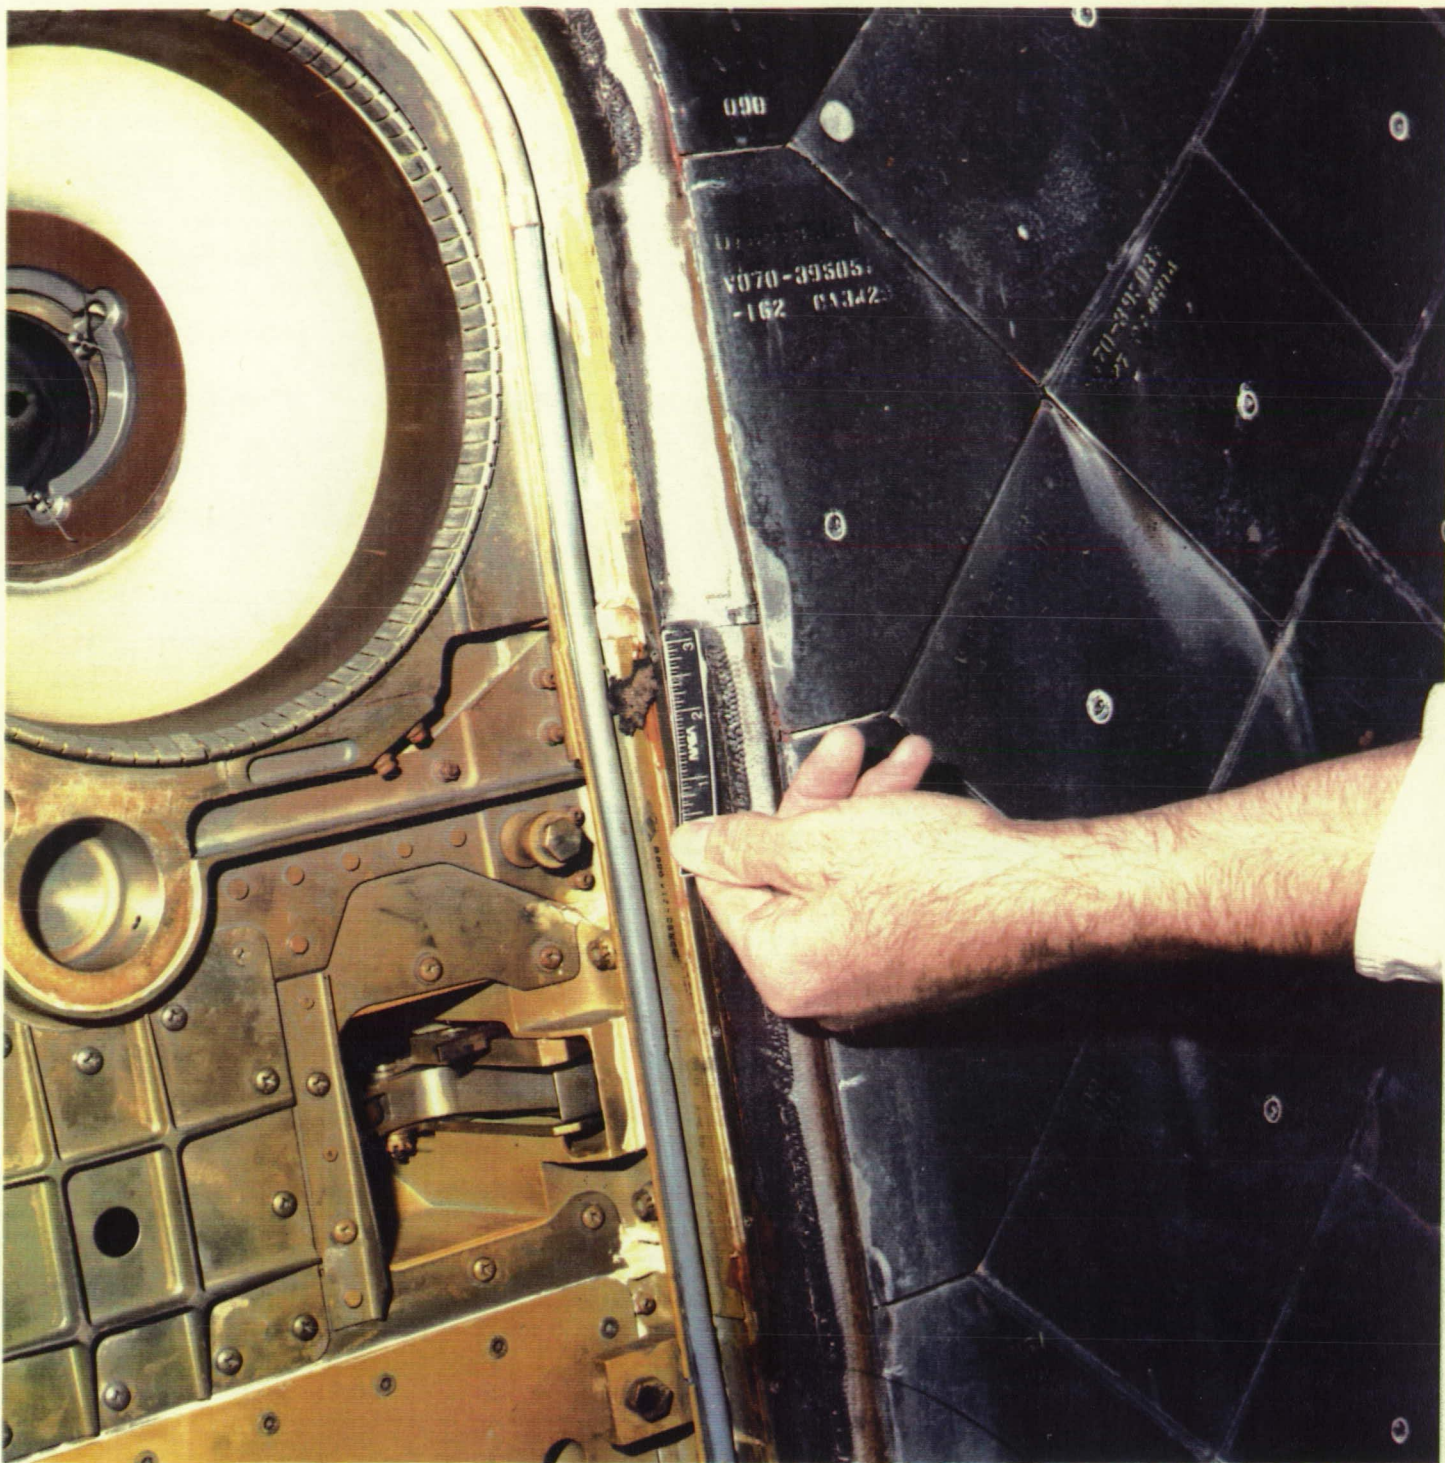
Brown/black-colored foreign material was removed from the LH2
ET/ORB umbilical for laboratory analysis

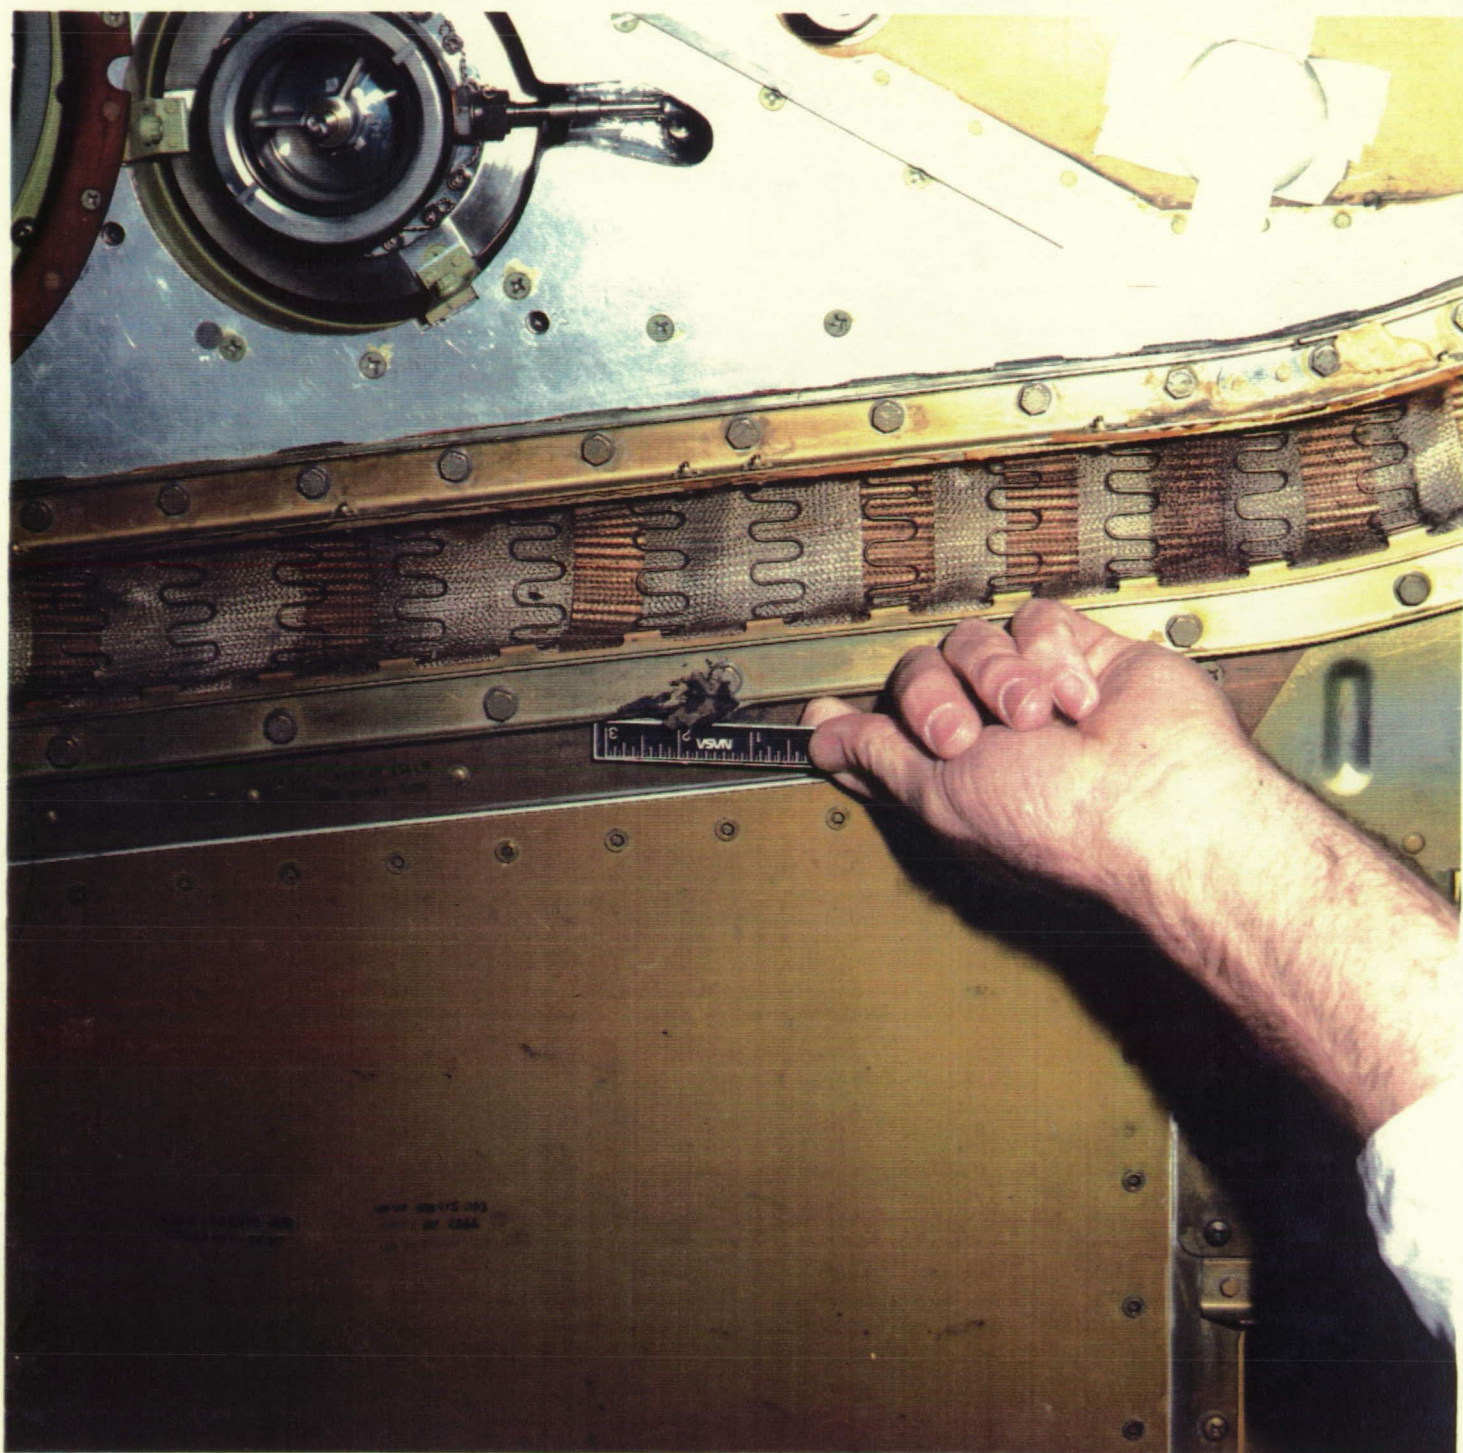
Brown/black-colored material removed from the LH2 umbilical
was closeout materials (foam and Viton rubber seal)

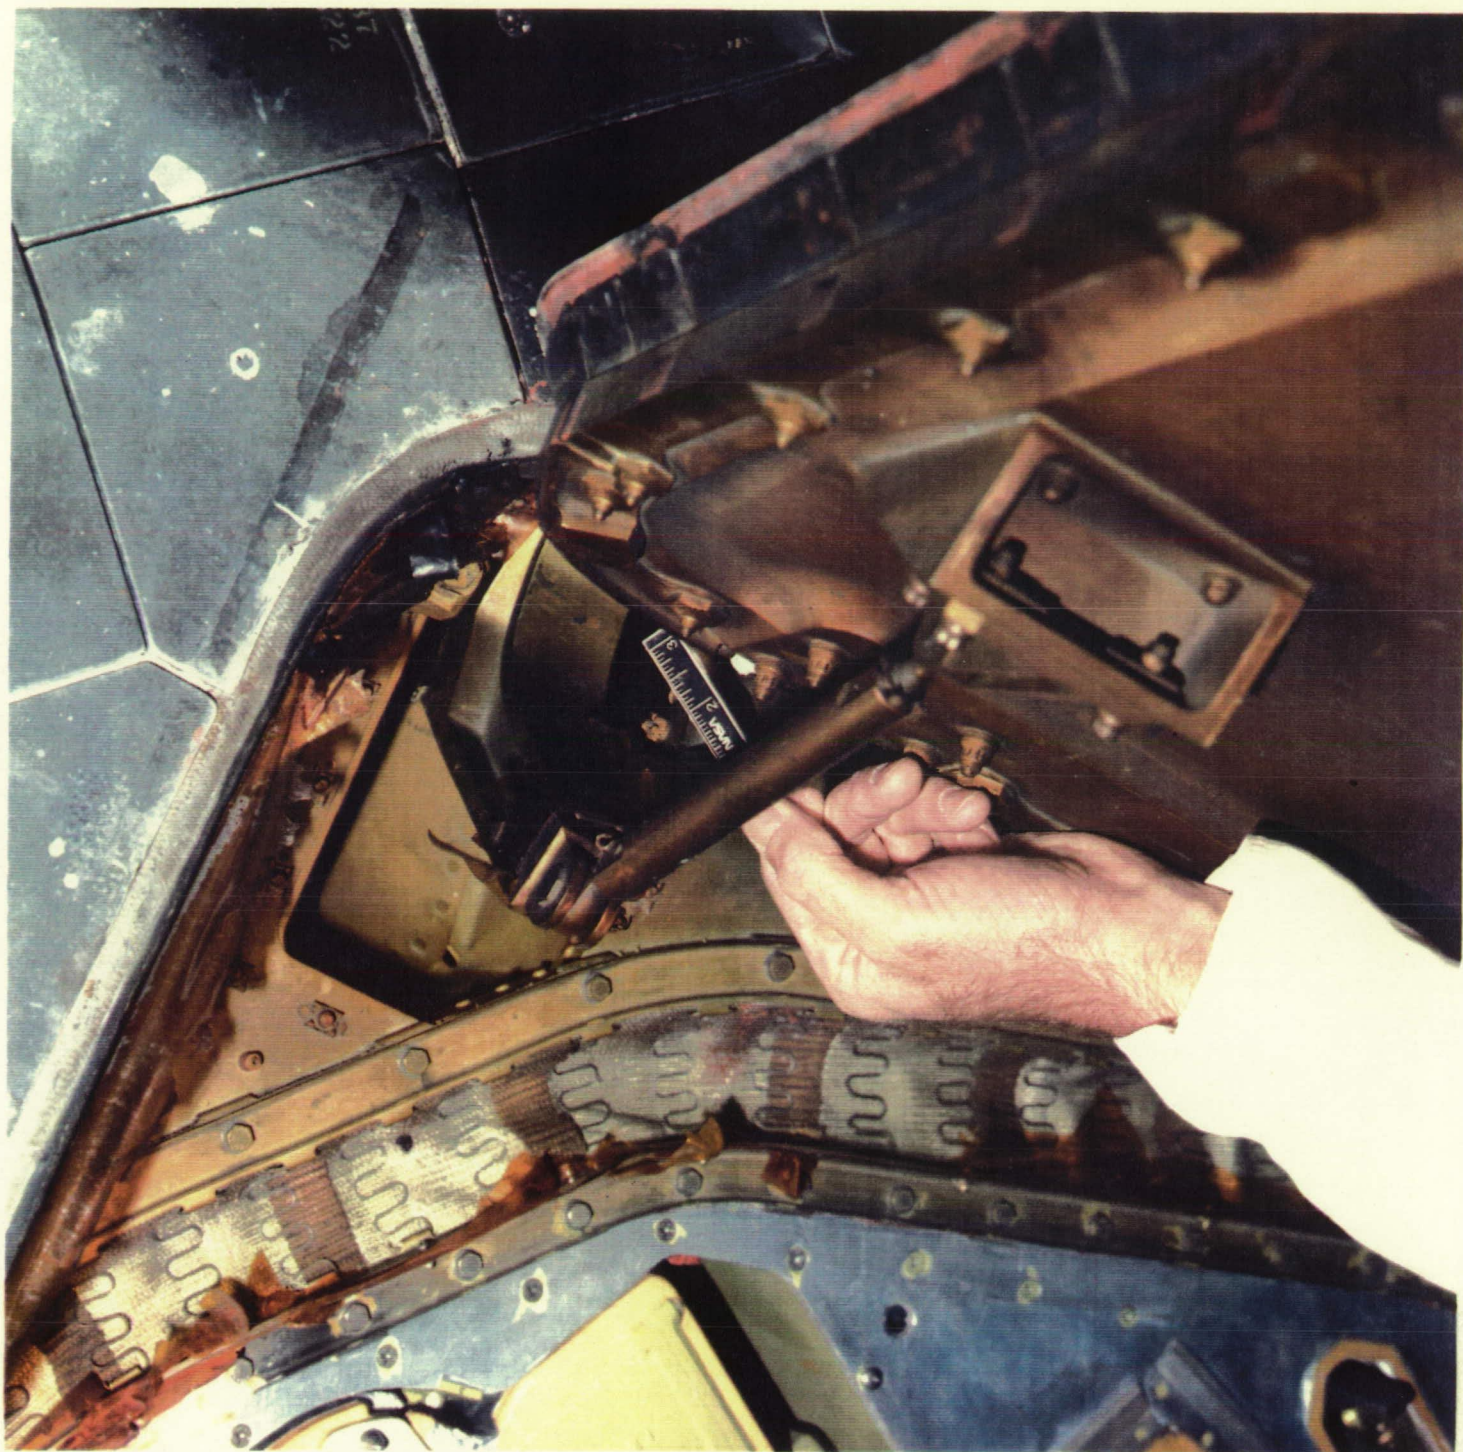
Analysis of light colored particle in the LH2 ET/ORB
umbilical revealed TPS closeout material
